## SCHEDULE OF CONDITION

Prepared November 2002

**BAR TAB**  
52 Wellington Street

<b><u>Address</u></b>	Presently known as Bar Tab, 52 Wellington Street, Luton
<b><u>Prospective Tenant:</u></b>	Tim Steele and Sam Ming
<b><u>Repairing Covenant:</u></b>	We have assumed the property has a full repairing and insuring covenant. Your legal adviser should confirm this and advise us of any unusual or onerous clauses immediately.
<b><u>Photographs:</u></b>	We have taken approximately 150 photographs during the course of this Schedule of Condition. We reserve the right to produce these photographs to establish the condition of the property over and above the ones included in the report.
<b><u>Limitations:</u></b>	As per our original Terms of Engagement, we would remind you specifically that:  We have not inspected parts of the structure which were covered, unexposed or inaccessible during our inspection. We therefore cannot confirm that such parts are free from defect, structural or otherwise.

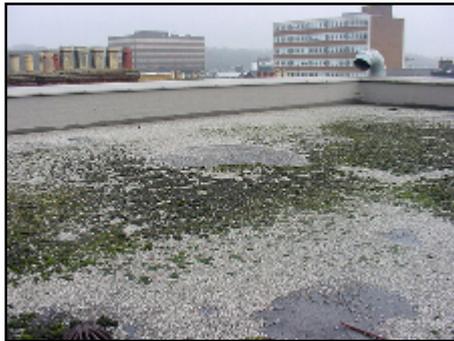
**Photo 81**

General view of the roof, the moss indicates that water is sitting on the roof and there are areas where the chippings need re-distribution.

**Action Required:** Redistribute chippings across the roof.

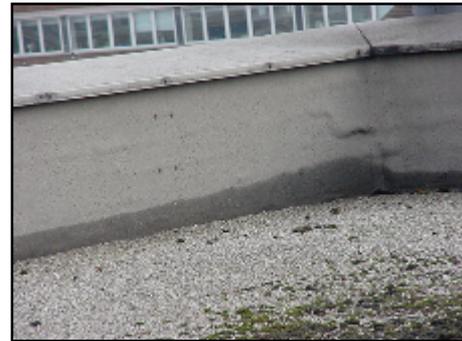
This photo shows deterioration in the asphalt flashing and also rising damp occurring.

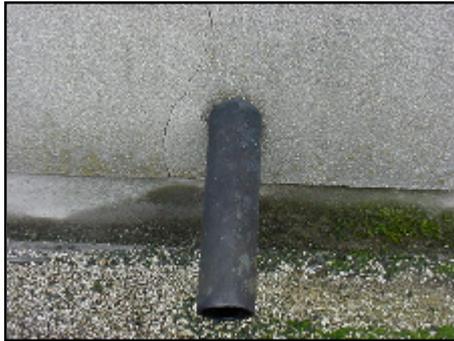
Vertical crack to the wall of the high level roof

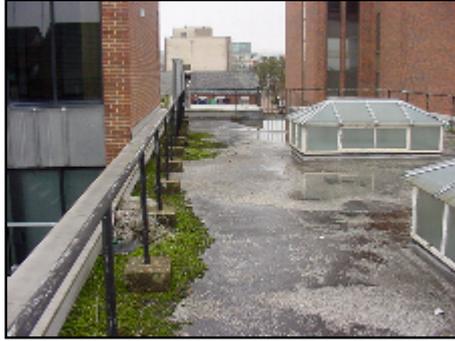
The property has extensive ponding, particularly to the rear right hand side and front right hand side.

General view of the roof. Note the exposed areas of asphalt and the ponding at the rear of the roof

**Action Required:** The entire roof should be altered to provide a fall to the outlets to stop the existing ponding.

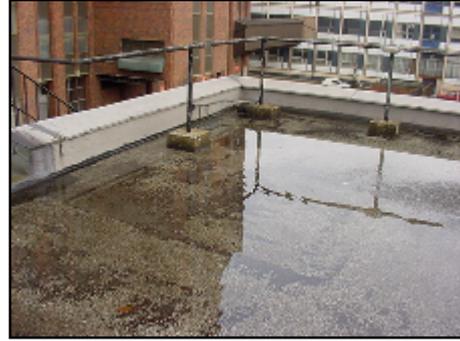
A close up of the ponding

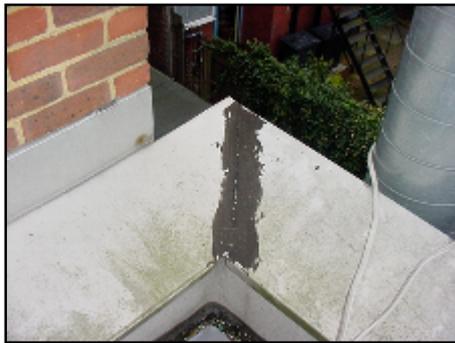
There is also a section of parapet wall to the rear, which has had metal capping added to it. This has had bitumen repairs indicating that there has been a leak in this area.

Repairs can be seen to have been previously carried out to the capping

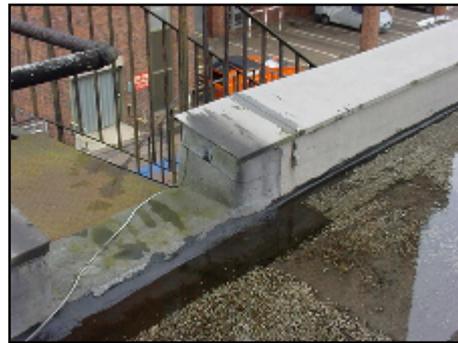
Repairs can also be seen to have been carried out to the roof and the junction of the parapet wall

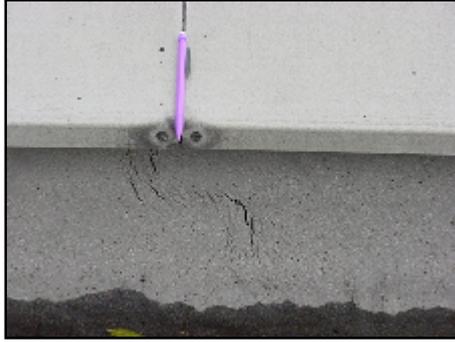
A close up of the parapet wall indicates this is starting to deteriorate

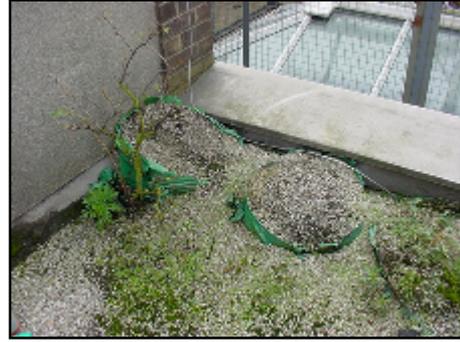
A build up of chipping has occurred in some areas on the roof, these need to be evenly distributed

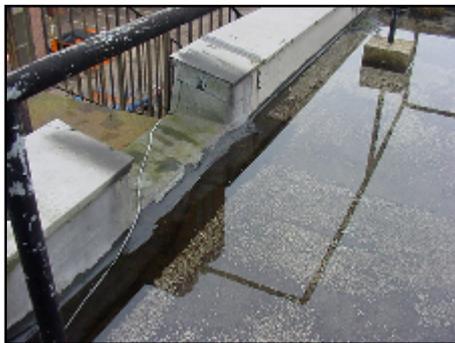
To the surrounding part of the property, there is a metal handrail, this is showing signs of corrosion and requires redecoration.

The handrail requires redecoration

**Action Required:** Landlord to redecorate.

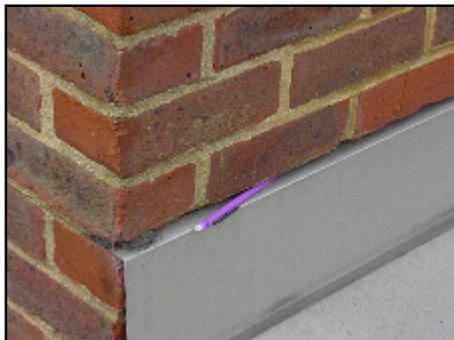
The flashing to the rear low-level building that butts the parapet wall has not been finished correctly.

The flashing has not been finished correctly to the adjoining property to the rear left hand side

**Action Required:** Landlord to contact adjoining neighbours and advise them of the detail.

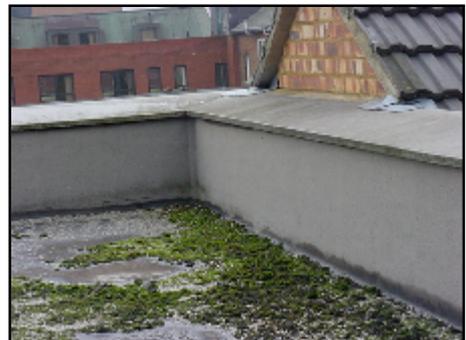
Where the adjoining building meets this property there should be a lead flashing. Note again the exposed areas of asphalt

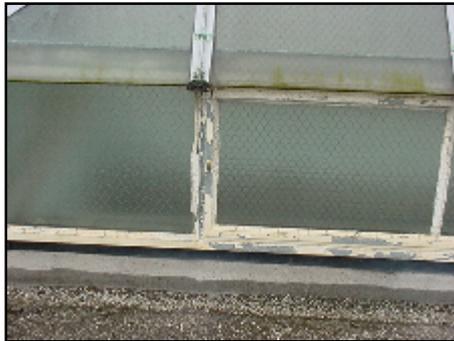
There are two roof lights, both are deteriorating and showing signs of paint flaking, which requires redecoration and repair.

A close up of the roof light showing the deterioration occurring.

Making good and redecorating required

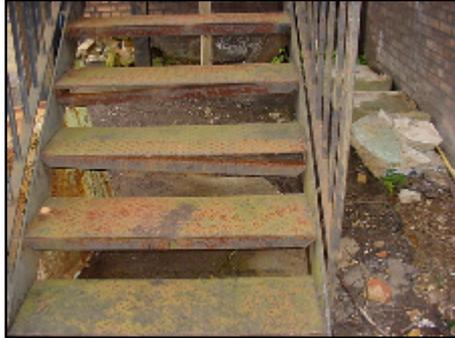
There is a metal fire escape to the rear of the property. This is generally rusty and requires a rust stop agent and a protective coating. Many of the stair treads have become unwelded from

General rusty condition of fire exit

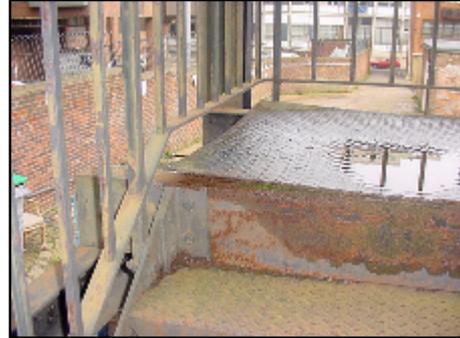
the stair structure beneath and require re-welding. Care should be taken when on this fire exit.

Showing corrosion and metal plate (tread) to have come away from the riser

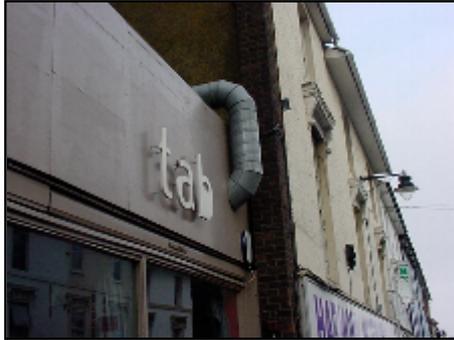
Ductwork normally requires planning permission and is not normally allowed to the front of a property in this type of location

**Action Required:** Your legal advisor to confirm whether planning permission has been obtained for all ductwork together with landlord's approval.

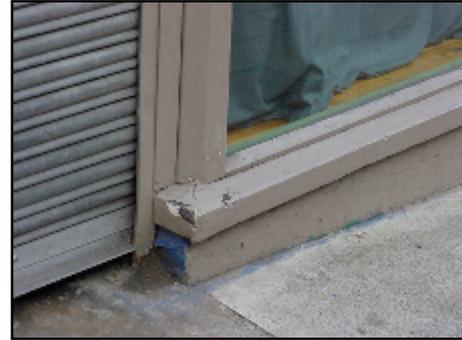
General damage to the window frame

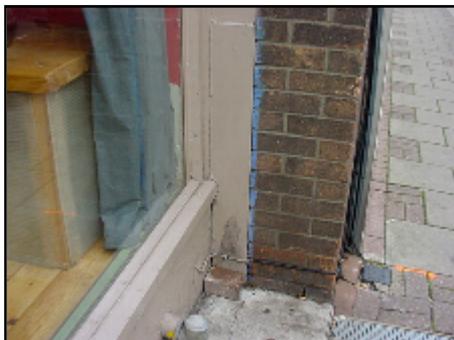
Paintwork on party wall and flaking paint to window frame

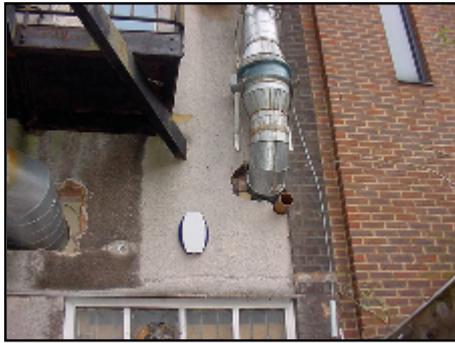
The ductwork has not been made good. Also note the pattern staining to the render, along with general deterioration

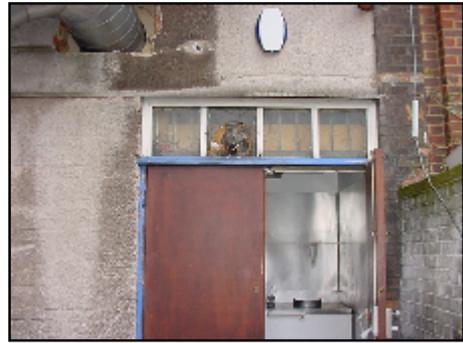
Note horizontal crack above the door and the general poor condition of the door and associated framework

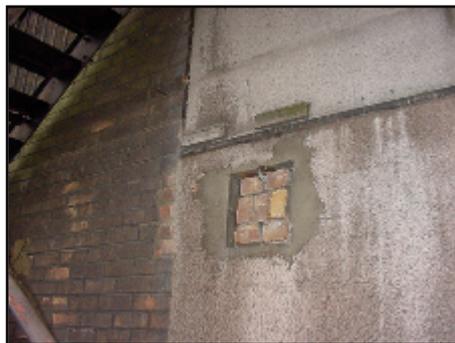
Making good has not been properly carried out

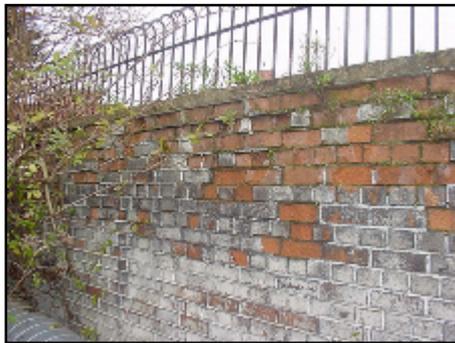
The boundary wall is spalling particularly heavily at the top.

Spalling to brickwork

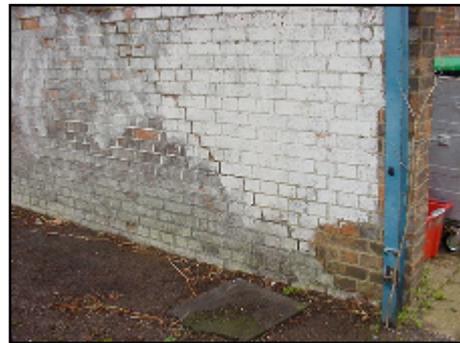
Horizontal cracking

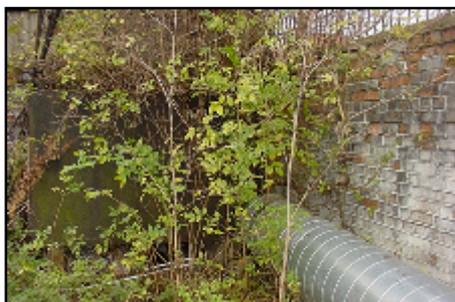
Generally the courtyard/parking area requires clearing of vegetation, tables, ductwork, an oil tank and generally rubbish.

Vegetation and rubbish left in courtyard

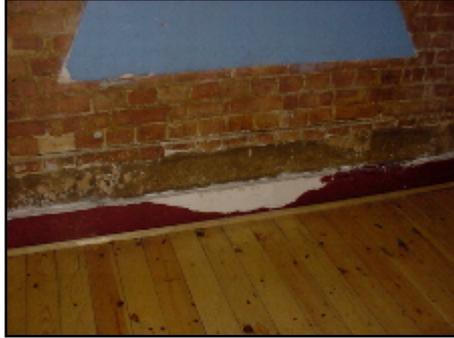
Damage at low level to the walls

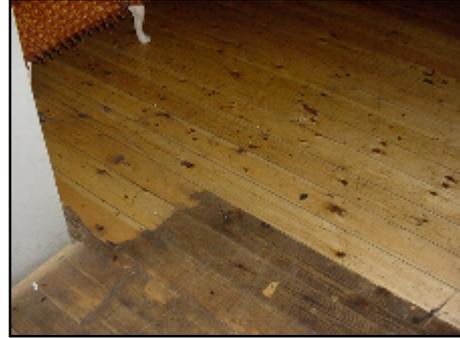
General marking to the floor

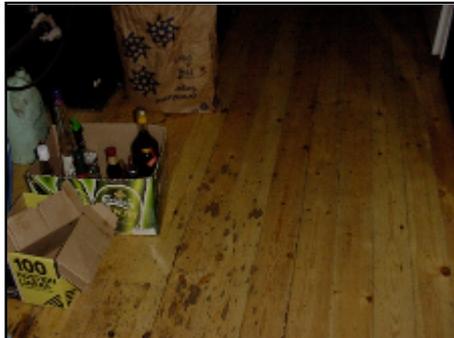
Close up of bar floor showing staining and deterioration to the varnish. Environmental Health require a smooth impervious surface in this area

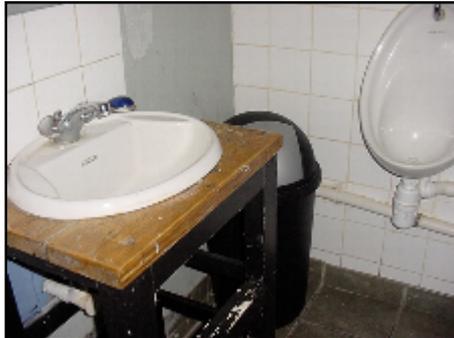
Vanity unit marked,  
sink has no mastic seal  
around it, ingrained dirt to  
tiling and marks to the walls

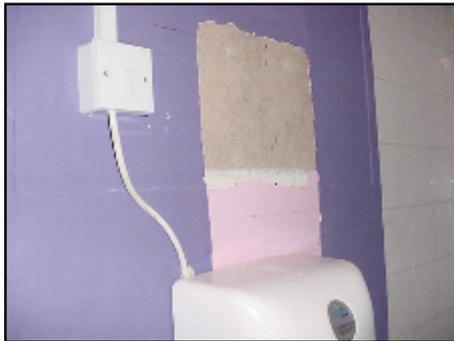
No making good has been carried out where units have been moved and ideally hand driers should be hard wired in.

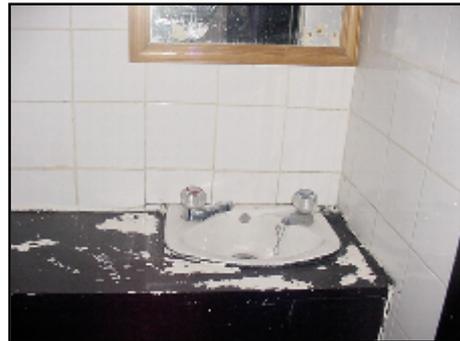
General marking and deterioration to vanity unit

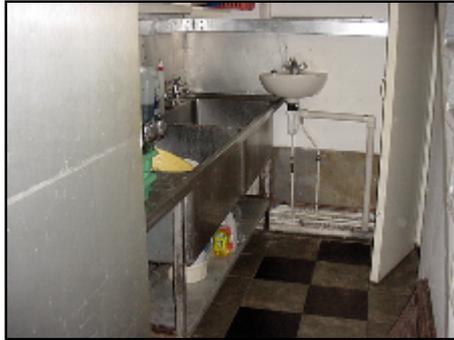
Note ingrained dirt to tiles and pipe work not boxed in

Pipe work has been left exposed and we would recommend that this be boxed in to create a clean, smooth impervious surface, which is required by the Environmental Health Officer.

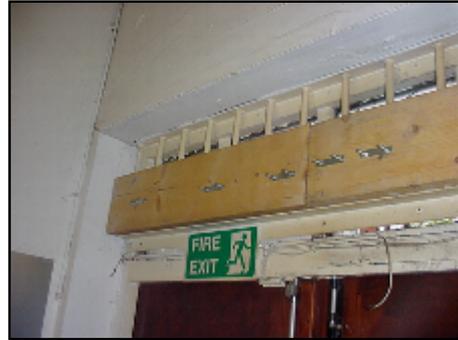
Rear fire exit with windows boarded over, we assume for security

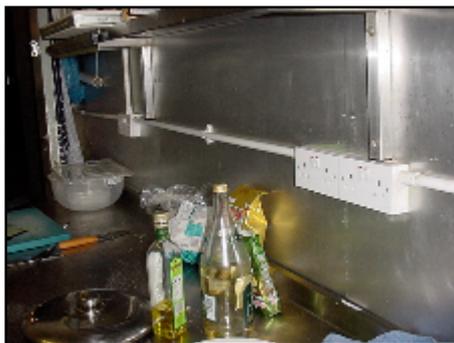
Surface mounted electrics within a cooking area, generally not considered good practice

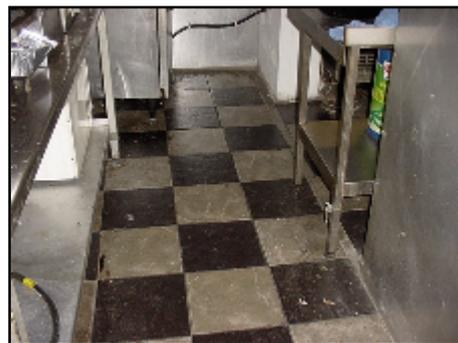
Ingrained dirt and no skirting at perimeter of wall to allow for easy cleaning
