FEASIBILITY STUDY
OF
Edisons, 42 King Street, Leigh, Cheshire

GEM Associates Limited

INDEPENDENT CHARTERED SURVEYORS

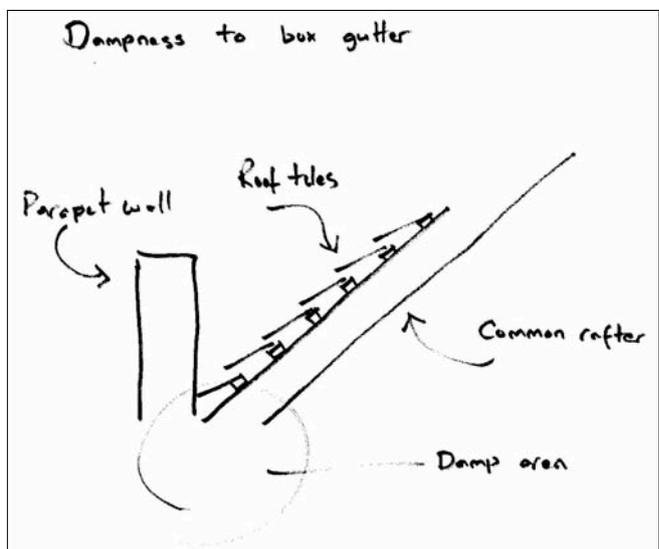
Due to the way the roof was originally designed with the parapet wall and pitched roof forming a gutter detail, dampness will occur within the roof joists. This has previously been left unrepaired and has caused extensive wet rot and dry rot.

Whilst we could see that some repairs have been carried out more recently they tend to be only to the common rafters and not to the main pre-fabricated trussed rafters where we could see wet rot and dry rot.

Dry rot is a major problem. The problem is that it can spread throughout a building. We could see examples of what is known as the 'fruiting body' within the roof structure and this means that there is a chance it has been passed throughout the building.

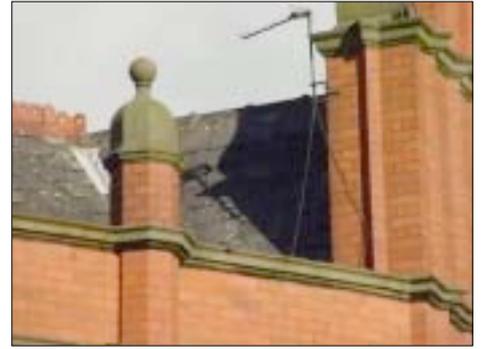
This photo is to the front of the property. Behind the wall you can see the slate roof; there is a box gutter where this meets the parapet wall.

ACTION REQUIRED: Any dry rot occurring within the property should not form part of your responsibilities under the terms of your Lease.

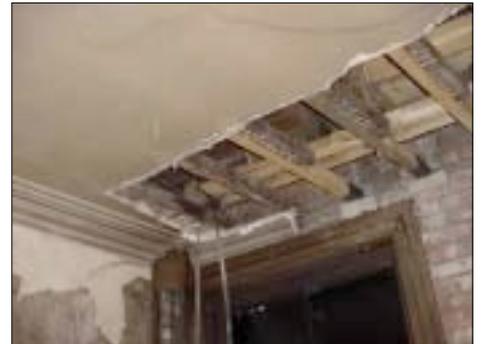
Within the building itself this has resulted in new roof joists being cut and spliced onto the old roof joists.

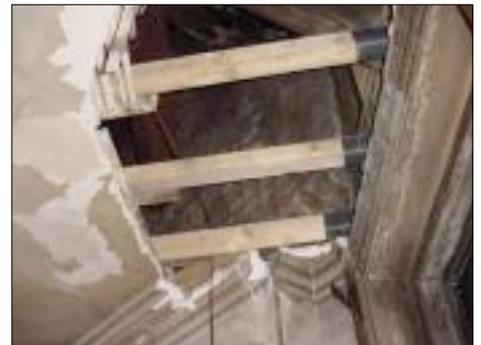
However from within the roof we can see that this has not been done properly.

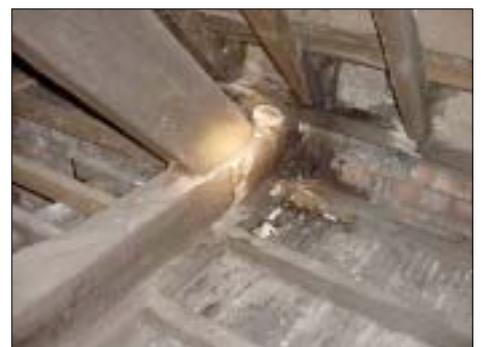
This photo identifies dampness to the base of the Victorian pre-fabricated truss. The pre-fabricated truss is a major element in this roof.

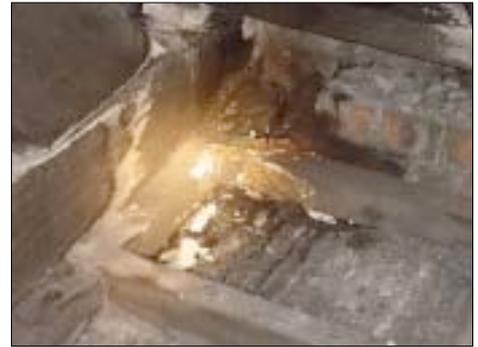
Here you can see wet rot/dry rot that is occurring in the structure.

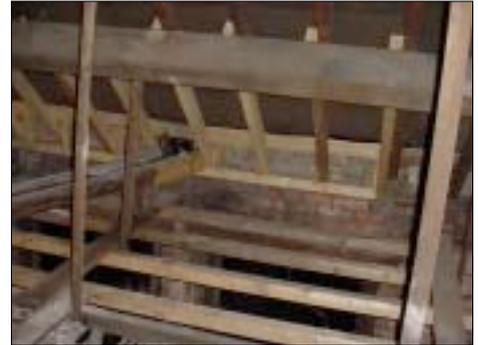
From within the roof we could see the work that has been carried out is quite extensive, however it is dealing with the 'effect' of water getting in and not the 'cause'; so the problem will simply re-occur.

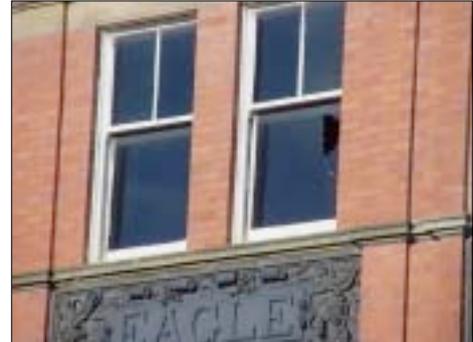
This is a general view of the sliding sash windows. Some are broken and cracked. These need replacing.

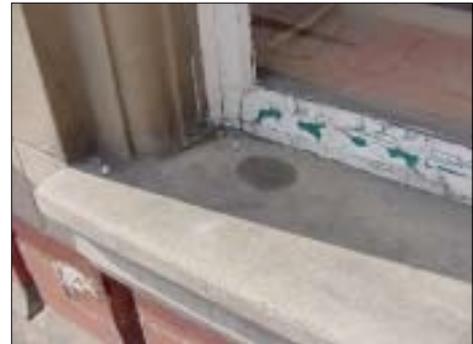
Redecoration required to the external joinery.

ACTION REQUIRED: Your Legal Advisor to ensure that specific clauses are within your part of the Lease that state when the external redecoration will be required by date.

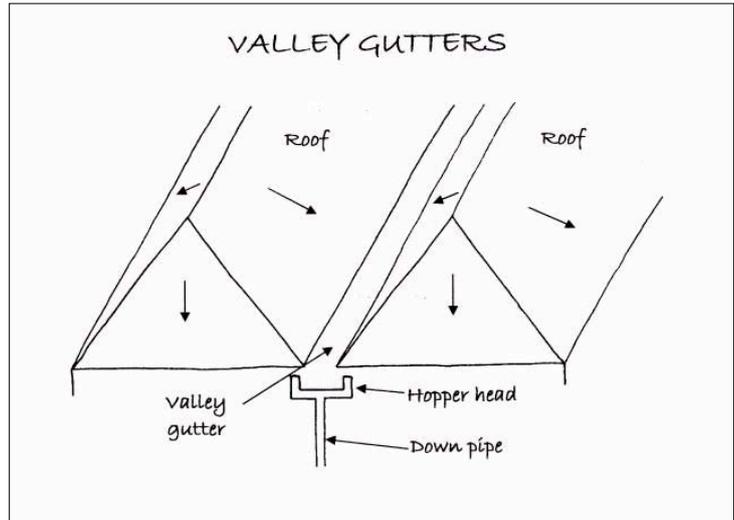
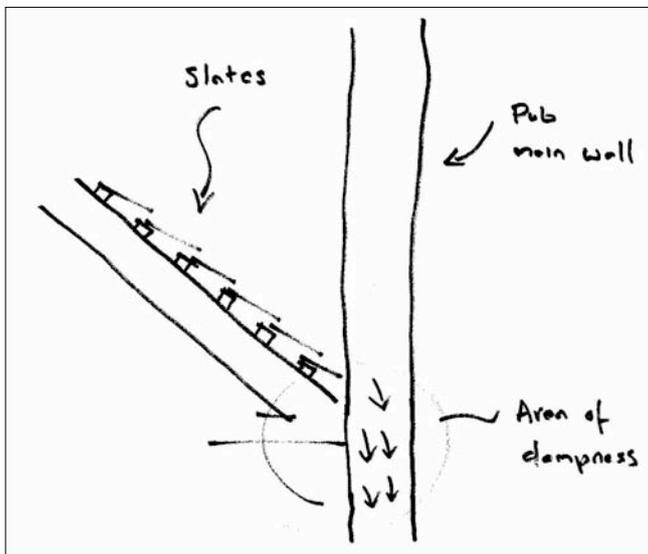
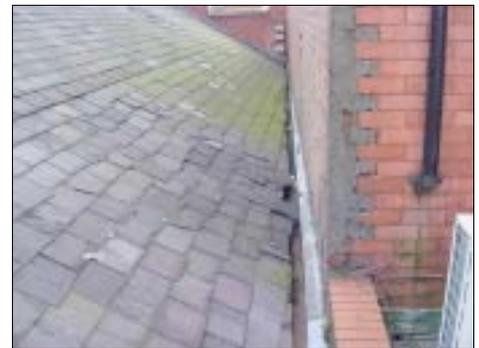
There is a very awkward valley gutter detail to the rear of the property. We believe this is leaking and from what we can see it is mainly the responsibility of the adjoining owner; however, it will be causing dampness into your property.

ACTION REQUIRED: The present owner should negotiate with the adjoining property owner and have the valley gutter renewed prior to the signing of the lease.

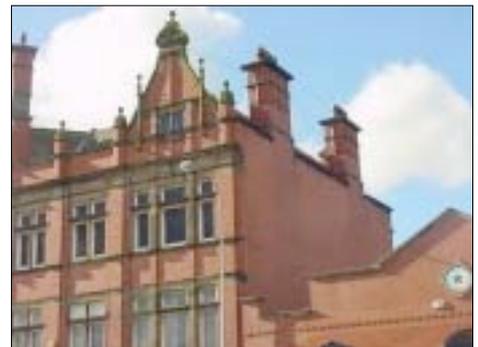
From the ground level and via our inspection with digital binoculars/camera we could see that some of the chimneys are leaning. In particular the chimneys in this photo appear to be leaning.

ACTION REQUIRED: The chimneys should be inspected.

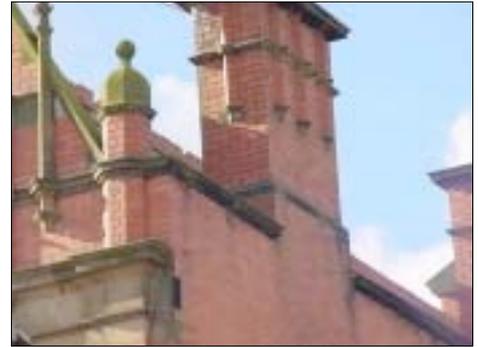
This photo is a close up and shows them to be in a reasonable condition, however we do feel they need further specific inspection.

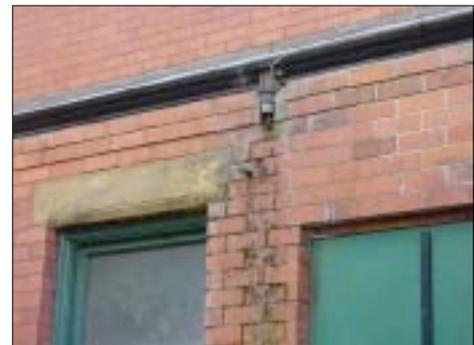
In this photo you can see a downpipe discharging onto the wall.

ACTION REQUIRED: Landlord to confirm what work he intends to carry out regarding the gutters and downpipes.

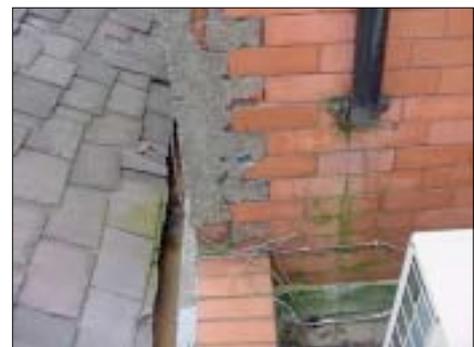
Here is another downpipe discharging onto the wall.

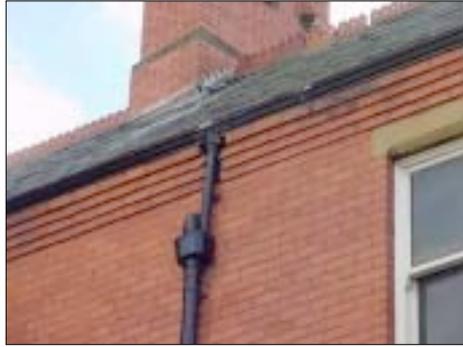
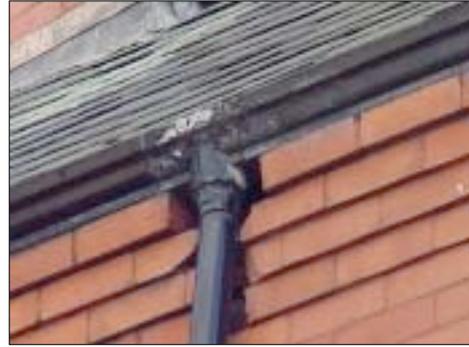
The gutter shown below on the left is leaking. The right hand photo is a close up.

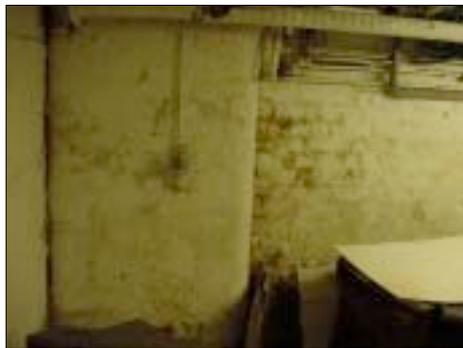
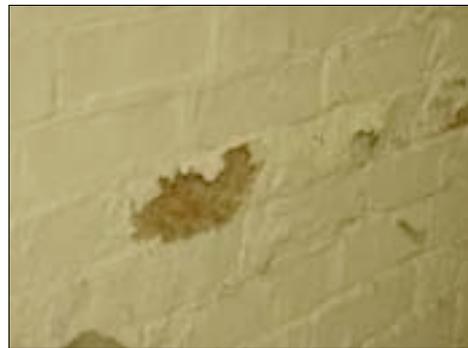
We do not believe that the present cellar is up to Environmental Health standards and is therefore not suitable to serve beer from.

ACTION REQUIRED: The present owners to bring the cellar up to Environmental Health standards (EHO).

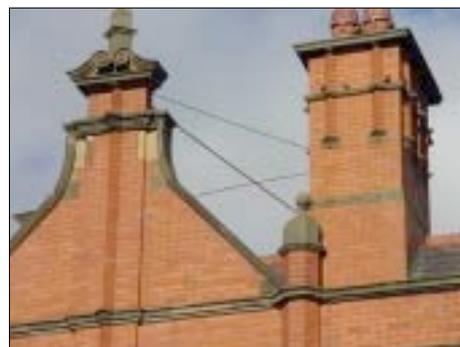
The property has large chimneys and parapet walls, some of which are braced.

Please see our comments in the Executive Summary with regard to the leaning chimneys and the dampness getting into the property.

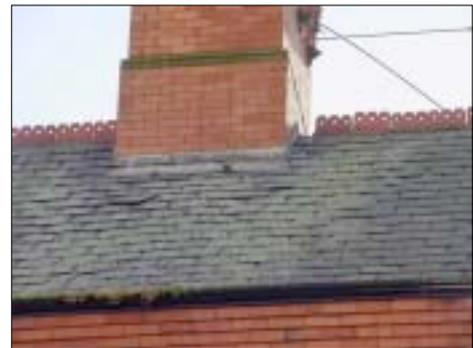
This photo shows a close up of the rear roof. There are some slipped tiles and the roof is starting to deteriorate.

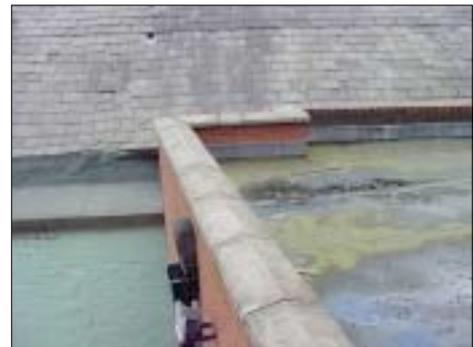
There is a flat roof to the rear, which was difficult to view as many areas were iced over at the time of our inspection. These areas have water on, which is known as 'ponding' and can be the areas where leaks occur.

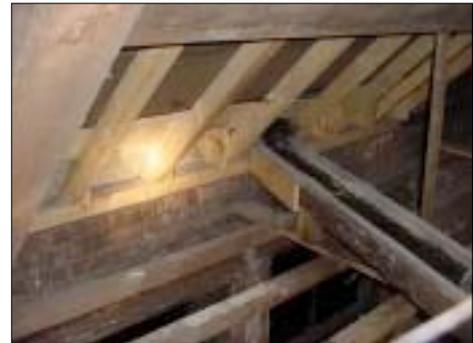
A view of some areas where the timbers have been replaced.

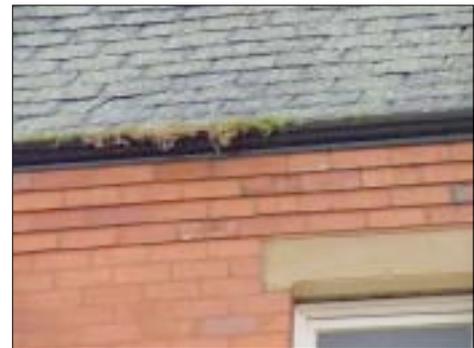
In this photo you can literally see vegetation hanging out of the guttering.

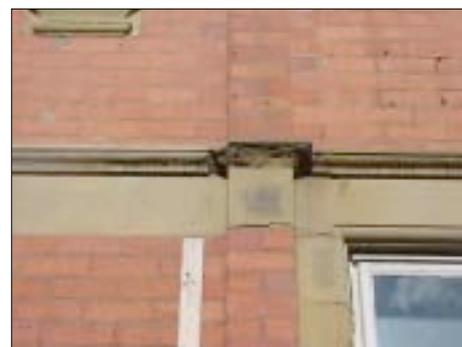
This photo shows a general view of the wall. You can see that some of the stone detailing is starting to deteriorate. This is the sort of thing that needs to be picked up in a Schedule of Condition to ensure that you do not have to make this good when you come to vacate the property.

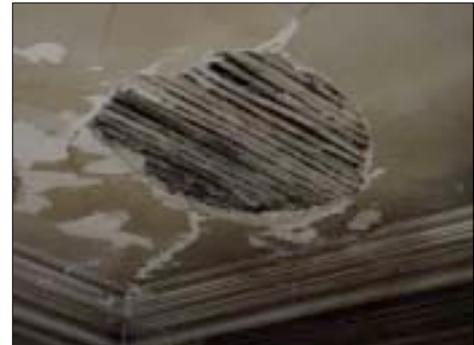
The ceiling was deteriorating/removed in many areas.
