## SCHEDULE OF CONDITION

Prepared November 2002

**BAR TAB**  
52 Wellington Street

<b><u>Address</u></b>	Presently known as Bar Tab, 52 Wellington Street, Luton
<b><u>Prospective Tenant:</u></b>	Tim Steele and Sam Ming
<b><u>Repairing Covenant:</u></b>	We have assumed the property has a full repairing and insuring covenant. Your legal adviser should confirm this and advise us of any unusual or onerous clauses immediately.
<b><u>Photographs:</u></b>	We have taken approximately 150 photographs during the course of this Schedule of Condition. We reserve the right to produce these photographs to establish the condition of the property over and above the ones included in the report.
<b><u>Limitations:</u></b>	As per our original Terms of Engagement, we would remind you specifically that:  We have not inspected parts of the structure which were covered, unexposed or inaccessible during our inspection. We therefore cannot confirm that such parts are free from defect, structural or otherwise.

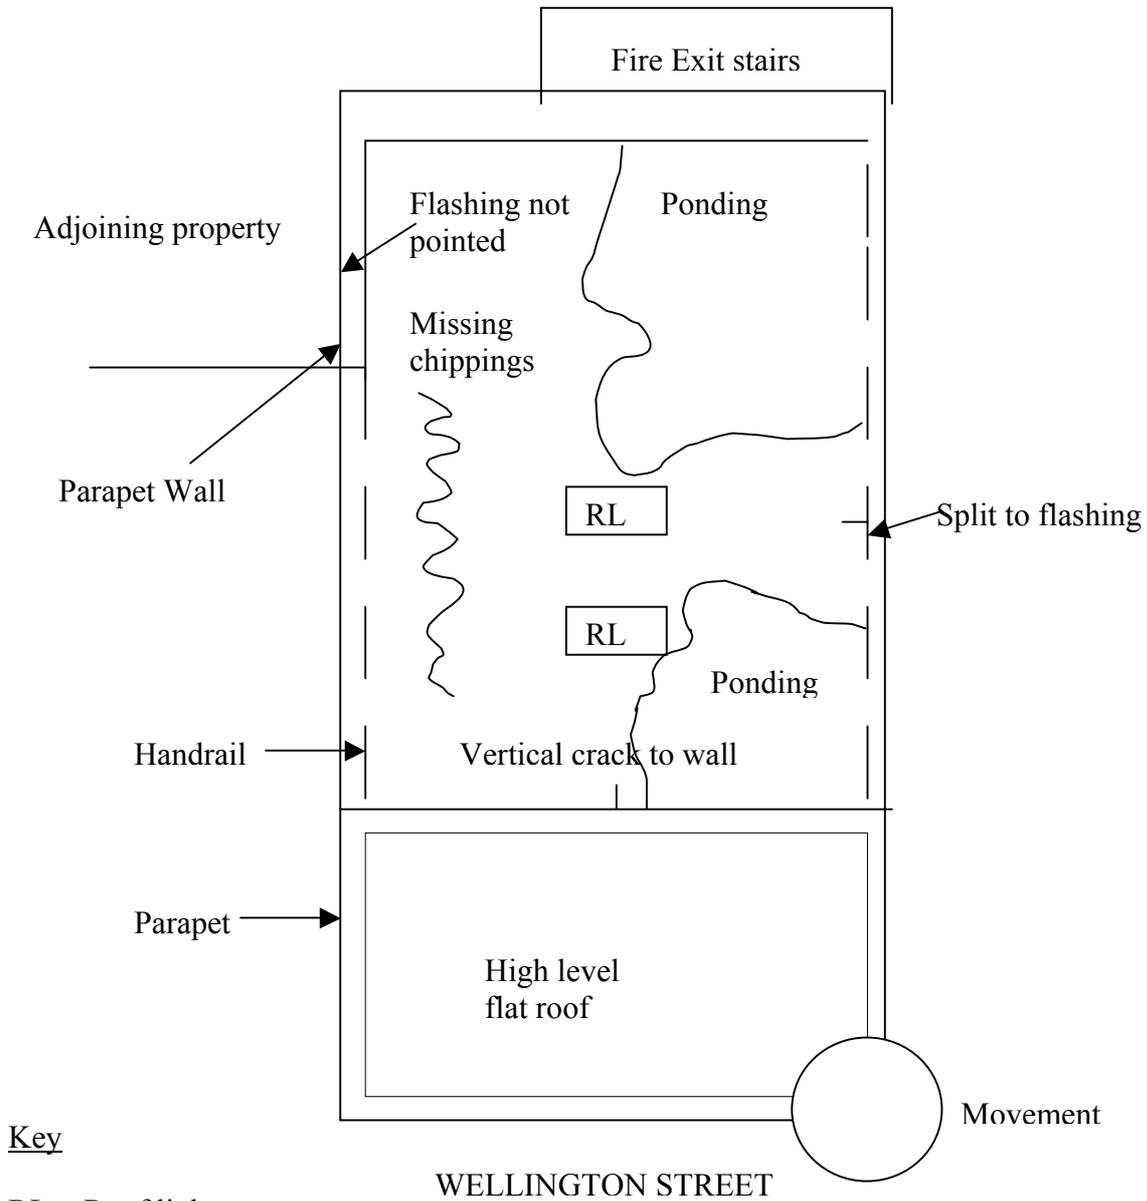
## EXTERNAL ROOF PLAN

This sketch shows a sample of issues and problems identified.

This is a flat asphalt covered roof with minimal falls. The flashing is also formed in asphalt. It is in reasonable condition. We would anticipate is as five to ten years life, assuming maintenance is carried out as a when required.

We believe that the capping and the asphalt have been added after the original construction to try and rectify a design defect.

Repairs can be seen to have been carried out to the rear right hand side in the form of a bitumen compound (rather than an asphalt repair). We have no way of knowing how long this has been leaking into the property, prior to it being 'repaired'.

There is also a section of parapet wall to the rear, which has had metal capping added to it. This has had bitumen repairs indicating that there has been a leak in this area.

To the surrounding part of the property, there is a metal handrail, this is showing signs of corrosion and requires redecoration.

The main part of the roof is asphalt, with a chippings covering. In areas the chippings have banked up and in other areas the chippings are missing from the roof. The chippings offer a reflective layer and protection from frost damage and they should be redistributed across the roof.

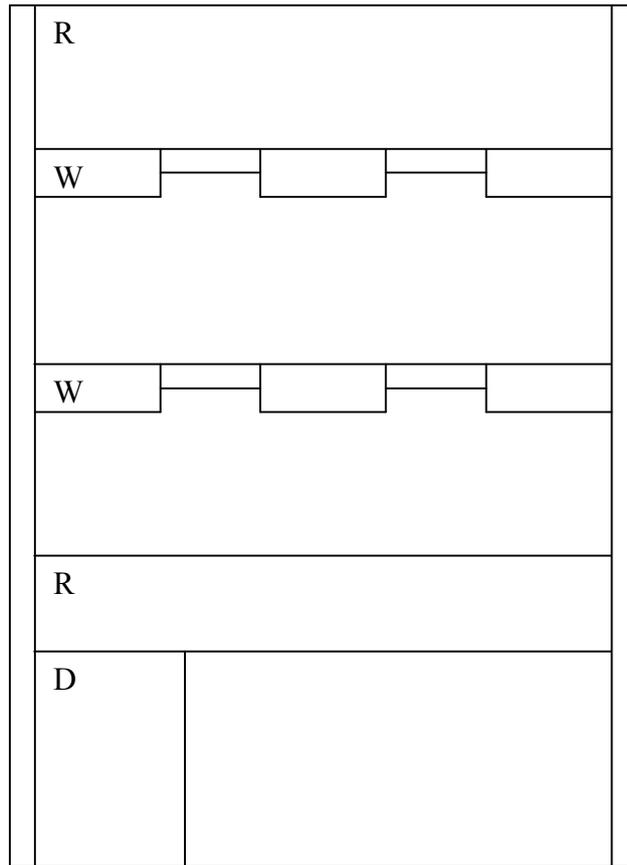
**FRONT ELEVATION**

To the front there is a fully glazed fixed pane window in a timber frame. To the upper floors there are timber casement windows, which are in a poor condition, probably needing replacement.

This sketch drawing shows a sample of the problems and issues identified.

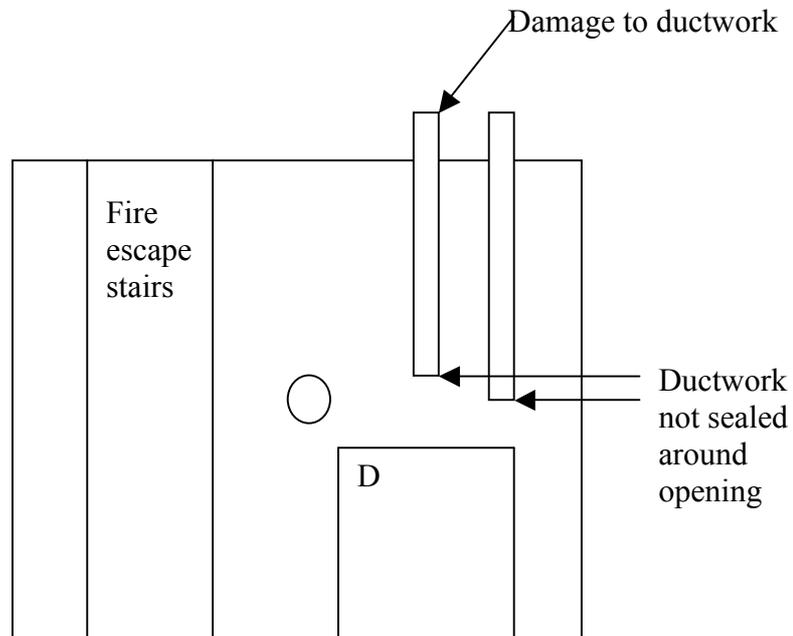
## REAR ELEVATION

To the rear of the property is a cast iron fire escape leading up to the roof level, which is corroding, and in need of repair.

This sketch drawing shows a sample of the problems and issues identified.
